# Archaeology

## Radar Investigation of Angkor Wat Temple in Cambodia

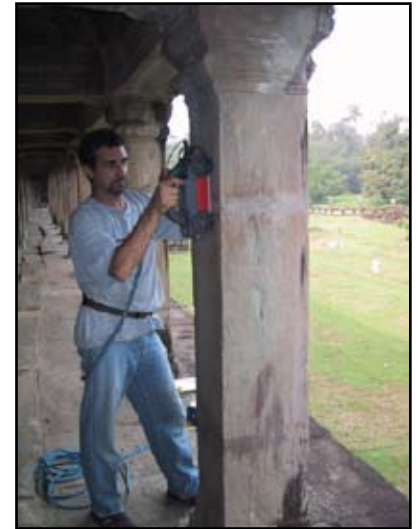
All radar data was gathered as 2D traces along the stone components of the gallery. The radar data taken on several of the stone columns identified metal inclusions (stone ties) within the columns and detected the presence of moisture at the base of one column (Figures 1 and 2).

Figure 1 . GPR scanning at "small" column at east column line. The metal ties are evident at the radar trace (below) as is the signal attenuation near the base of the column.

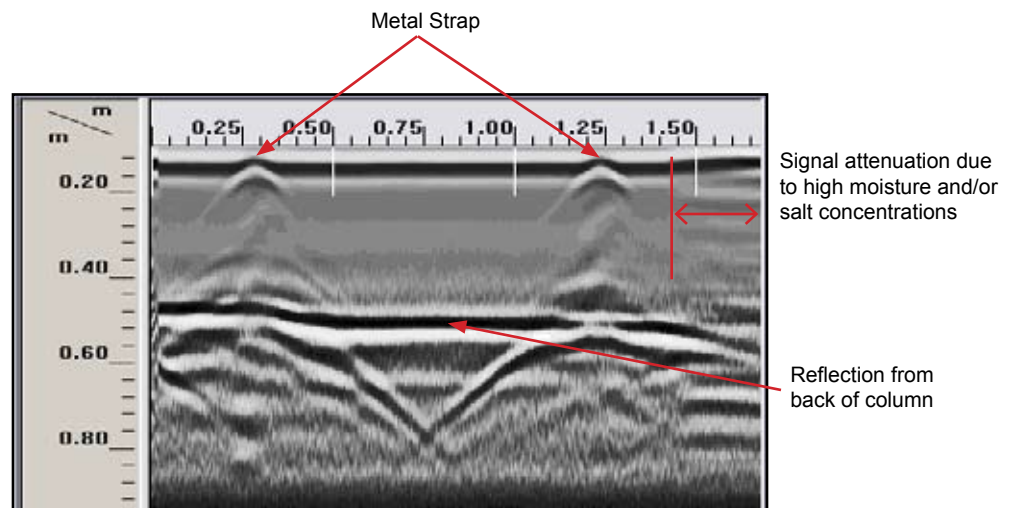
Figure 2. Radar trace from top to bottom of small column, scanning from the north face. Locations of the metal straps show clearly; note also the effect of moisture/salts near the column base.

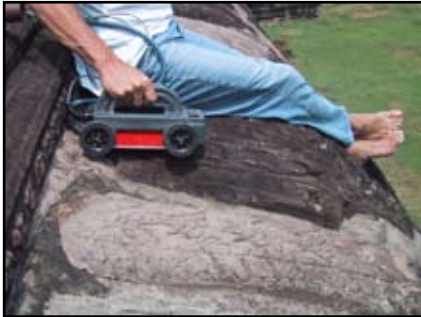
Radar traces were also recorded at many of the roof “nagas” (serpents) to identify the depth of patches and locate any subsurface cracking or patch delaminations. Scans were conducted by rolling the radar antenna down over the naga ridge from its apex to the first bed joint (Figure 3). Results of one roof scan are shown in Figure 5 below.

Figure 3. GPR search head was rolled over the ridge of each scanned naga to investigate subsurface conditions.

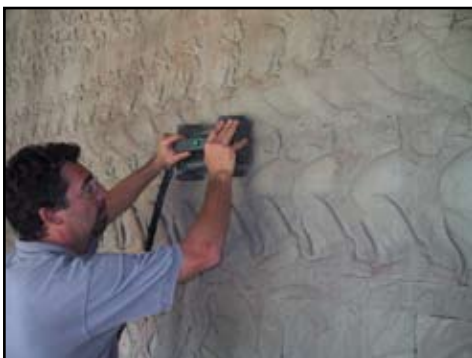
Figure 6. Microwave radar scanning on the gallery interior was complicated due to the deep relief of the carvings.

Scans on the bas relief sculpture gallery confirmed the relatively good condition of the stones, outside of localized areas that had salt/moisture damage (Figure 6).

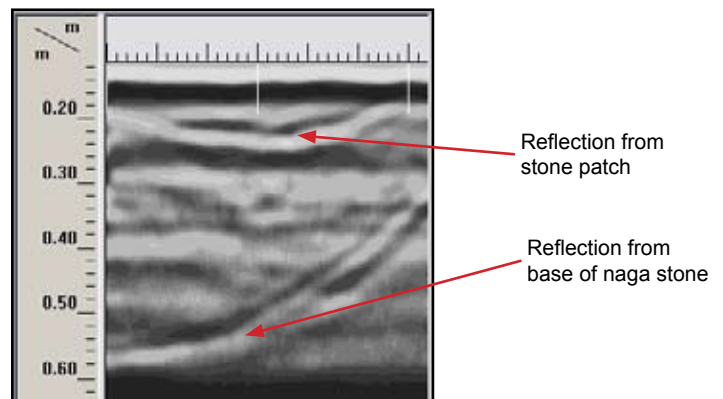
Figure 5. Radar trace at a stone with a patch. Based on the signal interpretation, the patch measures approximately 6 cm in depth and is delaminated from the stone beneath.
