## **Imaging Contractor Finds Hidden Objects Below Bay Area Rail Stations**

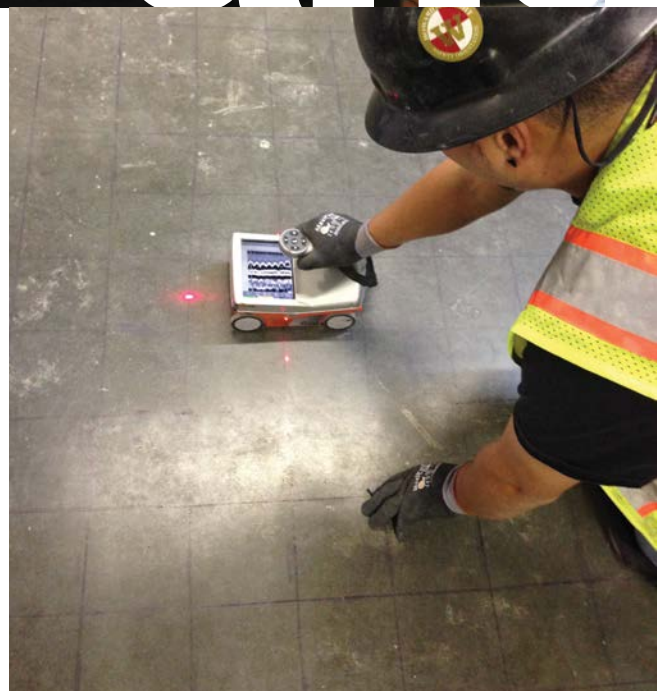
Operators performed GPR imaging in station buildings and outdoor parking areas.

Scanning operators began by performing an electromagnetic inspection of the stations and verifying utility lines that were marked on “as built” drawings. Station operations were not to be interrupted by the work, so the contractor used cones and caution tape to keep rail users from entering scanning areas. Once complete, GPR equipment supplied by Geophysical Survey Systems, Inc. (GSSI) was set up with 1.6 MHz and 2.6 MHz antennas to inspect up to 16 inches deep in reinforced concrete. This allowed the operators to locate small utility lines that may otherwise have been obscured by steel reinforcement using larger antennas. It took two operators four days to complete the first phase of GPR imaging.

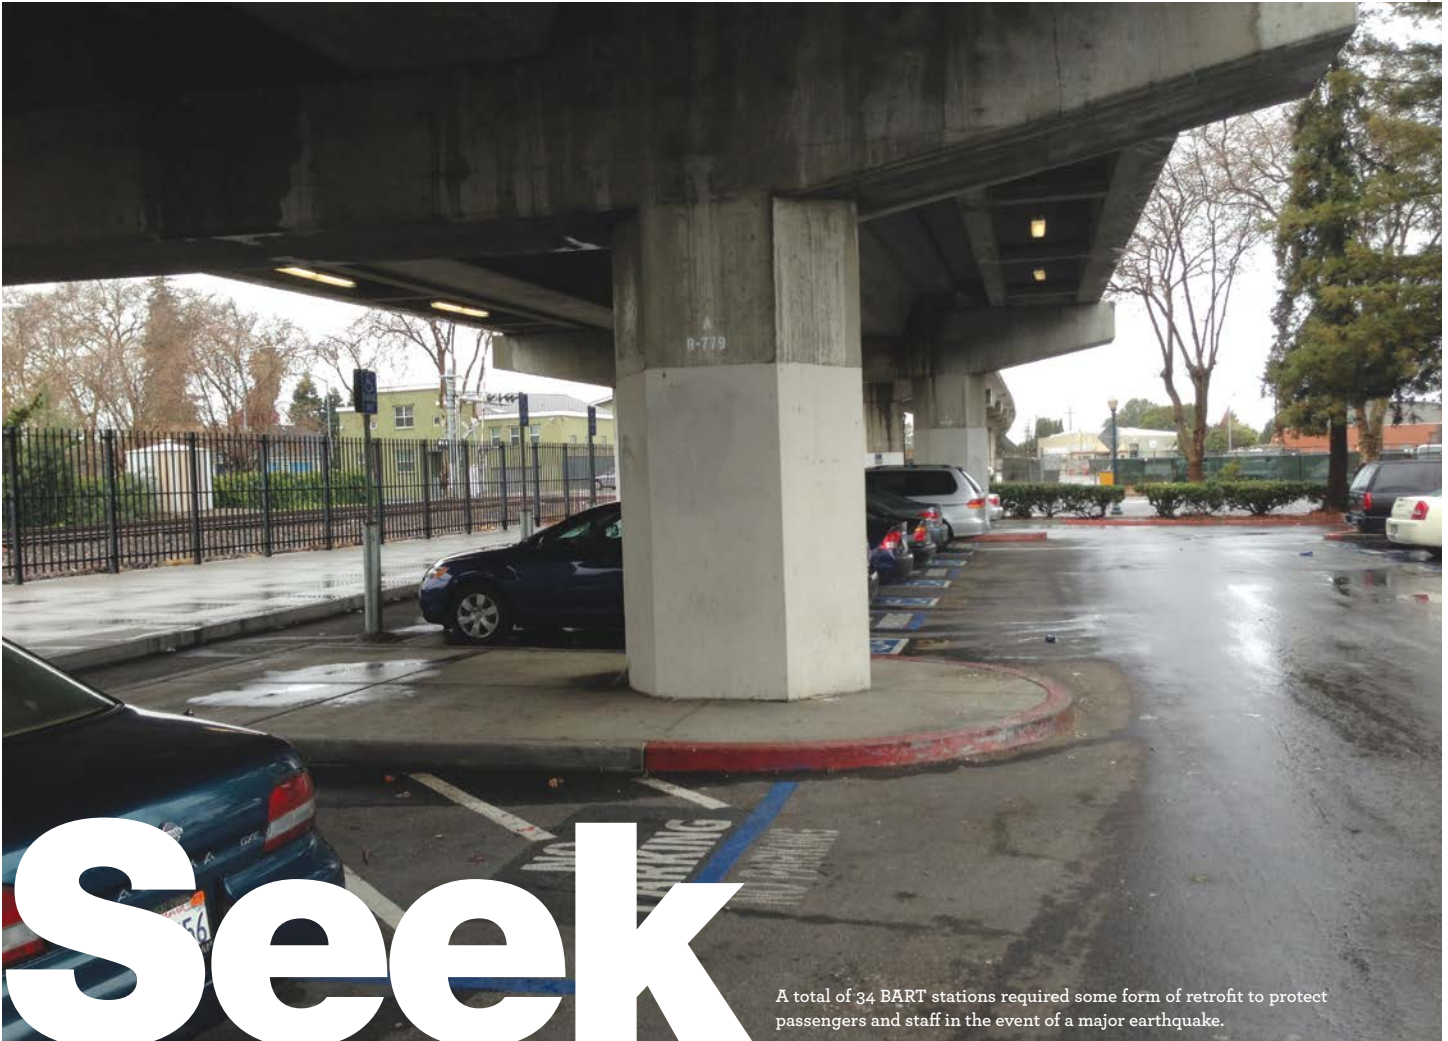
A total of 34 BART stations required some form of retrofit to protect passengers and staff in the event of a major earthquake.

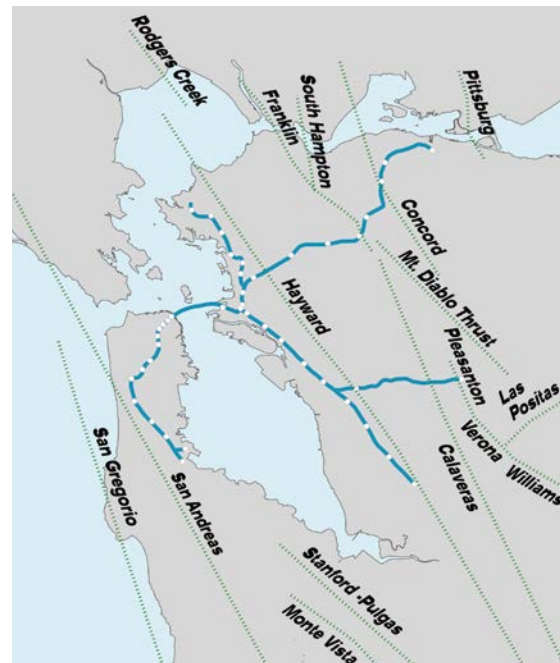
The blue lines indicate BART routes. Green lines indicate known earthquake fault lines.

A recent U.S. Geological Survey statistical analysis concluded that the Bay Area is likely to be hit by a major earthquake sometime within the next 30 years. Because the BART system crosses over and runs close to several fault lines, it is also likely that a major seismic event will heavily impact the system. To safeguard the public's significant investment in the system and ensure their safety, BART initiated the Earthquake Safety Program. Portions of the original system—74 miles of track, 34 stations and various buildings and structures—are being upgraded by using the latest seismic standards to improve the structural integrity of BART facilities. The Program is scheduled for completion in 2018.

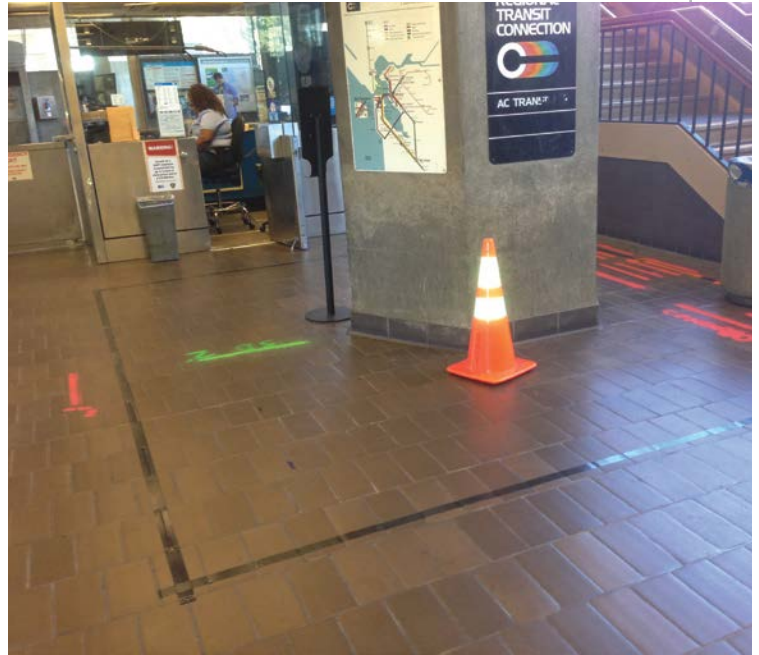
This form of non-destructive testing enabled station operations to continue as usual.

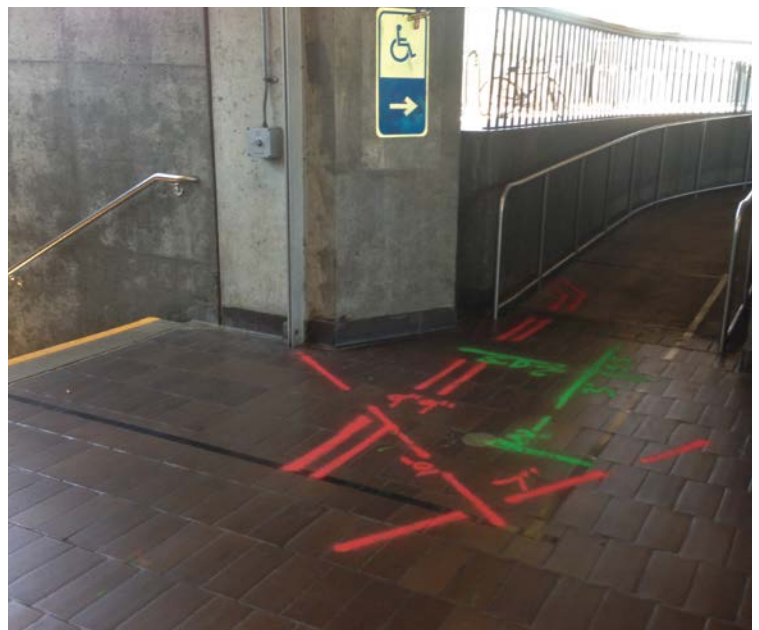
The results of the scanning and imaging work will assist in the installation of strengthening devices on buildings and structures.

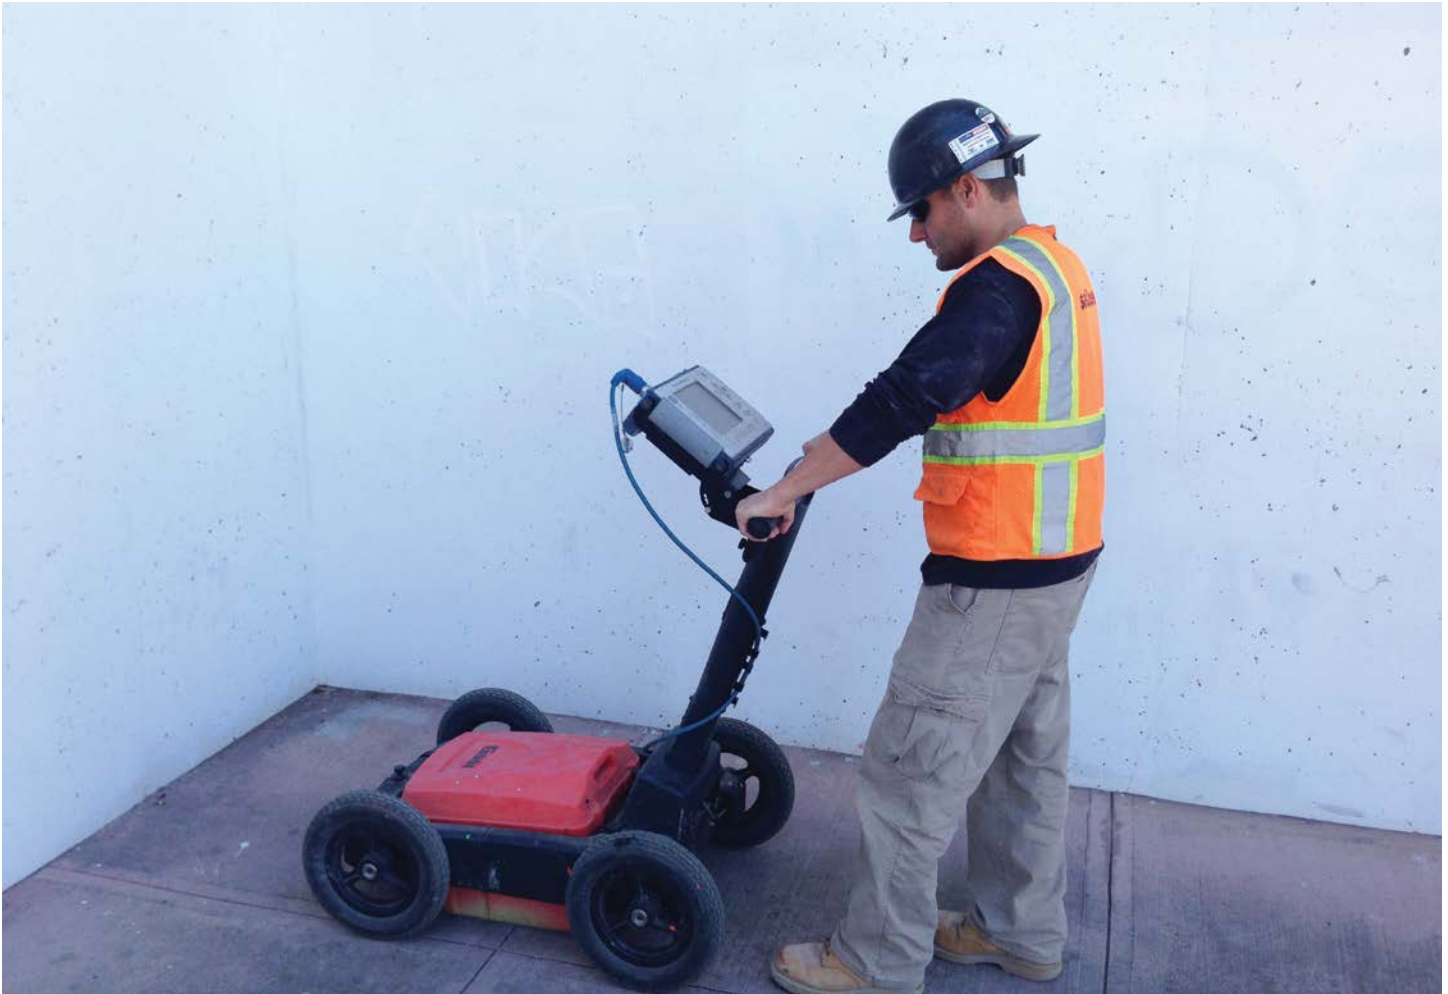
A 400-MHz antenna was used to locate and identify utilities buried up to 5 feet deep in reinforced concrete.

Next, the team from Safe2Core utilized a 400-MHz antenna to survey the specified areas of the three stations and locate objects positioned up to 5 feet deep. The use of different antennas was crucial for this project. Some interior areas of the three BART stations contained highly congested sections of utility runs, which rendered other utility location methods useless due to high levels of interference. GPR was the only technology that allowed operators to distinguish between the different types of lines and materials. This second phase was completed over three days at the Hayward, Oakland and San Leandro stations.

The team from Safe2Core completed all scanning and imaging tasks at the three BART stations over a seven-day period, covering around 80,000 square feet. Operators used a 1.6-MHz StructureScan Mini, a 2.6-MHz StructureScan HR and a SIR-3000 unit with a 400-MHz antenna, all from GSSI. Employees were provided with all standard items of personal protective equipment for the work.
