Bridge Deck Evaluation

Air-Launched Horn Antenna for Bridge Deck Analysis

In a collaborative effort between GSSI and the Maine Department of Transportation, both a 1.5 GHz ground-coupled antenna and a 2 GHz air-launched horn antenna were used to comparatively evaluate the condition of an asphalt overlaid bridge deck located in Lewiston, Maine.

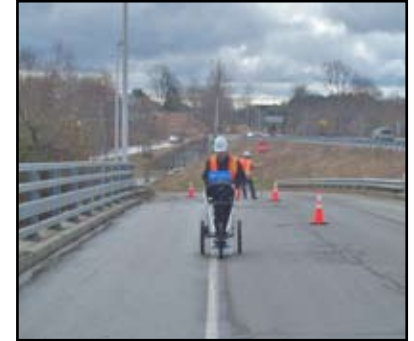
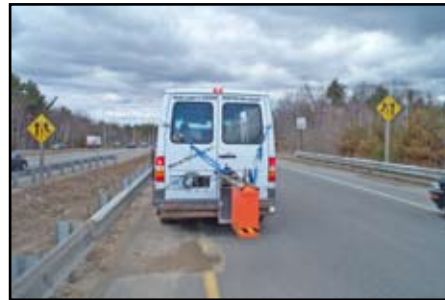
GPR data was first collected along the bridge deck in lines parallel to the direction of traffic using the 1.5 GHz ground-coupled antenna. The profile lines were perpendicular to the transverse direction of the upper-most rebar. These data lines were acquired at two foot spacing by simply walking the cart-based BridgeScan system across the bridge in the direction of traffic.

Similar data lines were also acquired using the 2 GHz air-launched horn antenna. The 2 GHz antenna was mounted to the rear of a van and suspended approximately 18 inches above the bridge surface. A wheel-mounted DMI provided distance information to the radar control unit.

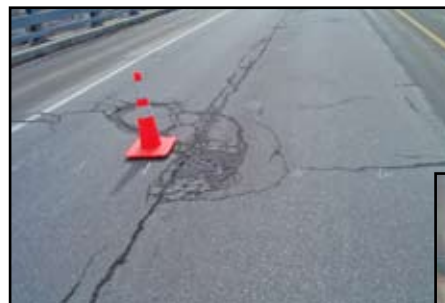
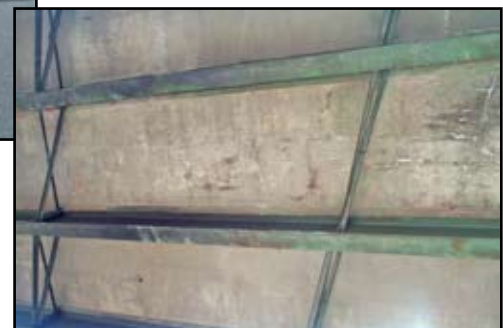
Top of bridge deck (left)
View of underside of bridge deck (bottom)

The bridge deck, a portion of the Veterans Memorial Bridge, was suspected by the Maine DOT to be considerably deteriorated. The bridge, which was constructed in 1971, had been repaired numerous times and was scheduled for rehabilitation. This presented an excellent opportunity for evaluating the 2 GHz horn antenna for bridge condition assessment.

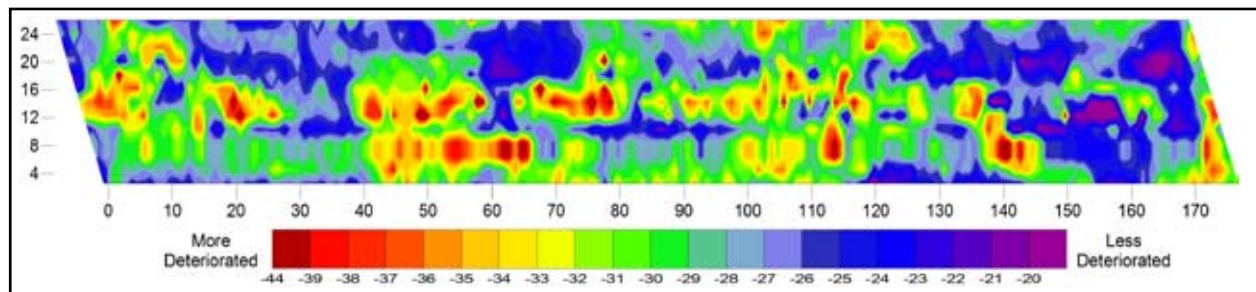
2 GHz air-launched antenna data

The GPR data was processed with GSSI's RADAN software using the Bridge Assessment Module. The results were used to produce color-coded deterioration maps of the bridge deck. Results from the 1.5 GHz ground-coupled antenna and 2 GHz air-launched horn antenna demonstrated excellent correlation. In addition, the deterioration maps from both antennas were compared with visual data obtained from top-side and bottom-side visual inspections and exhibited excellent correlation.

Contour maps created using Surfer® by Golden Software
