CASE STUDY

PaveScan® RDM 2.0

Using PaveScan Technology to Measure New Pavement Uniformity

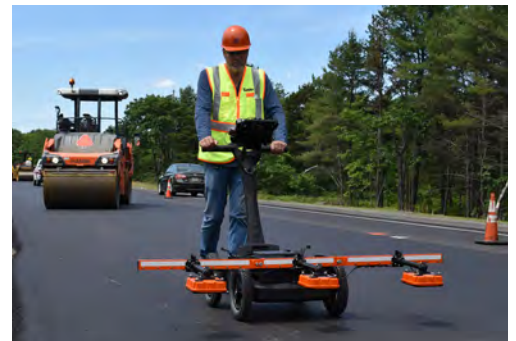
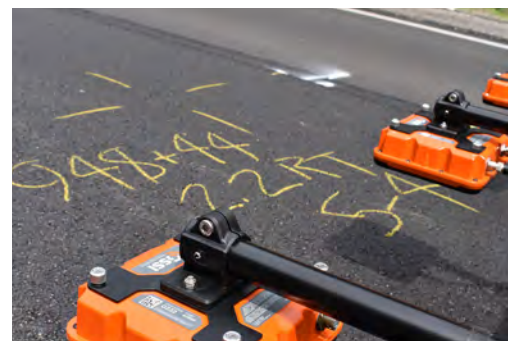
The PaveScan RDM technology has been proven to have a strong correlation between the dielectric value and the air void content. Each sensor on the system collects a continuous line of dielectric values displayed as a contour map. In this project, the data clearly identifies areas of poor uniformity along the shoulder and middle joints. Maine DOT was also able to output the statistics of the survey and export the .csv file and .kml files for further evaluation.

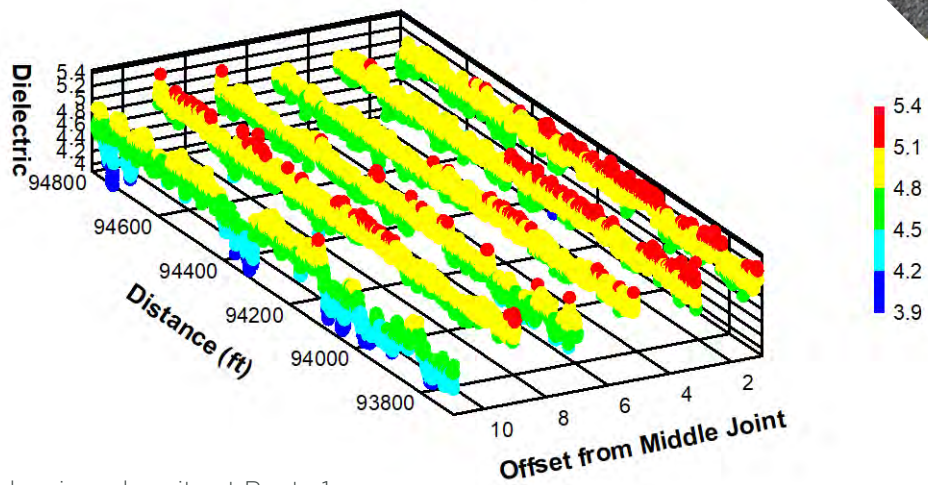
Rt 1 South Bound, Travel Lane
Station 937+00 - 948+00

Data collected and reviewed onsite at Route 1, South Bound, Travel Lane. Station 937+00 - 948+00.

Note the lower dielectrics near the shoulder joint, displayed in blue, and higher dielectrics along the middle joint, in red.

Using the PaveScan results, Maine DOT was able to identify a possible roller issue with the pavement contractor.

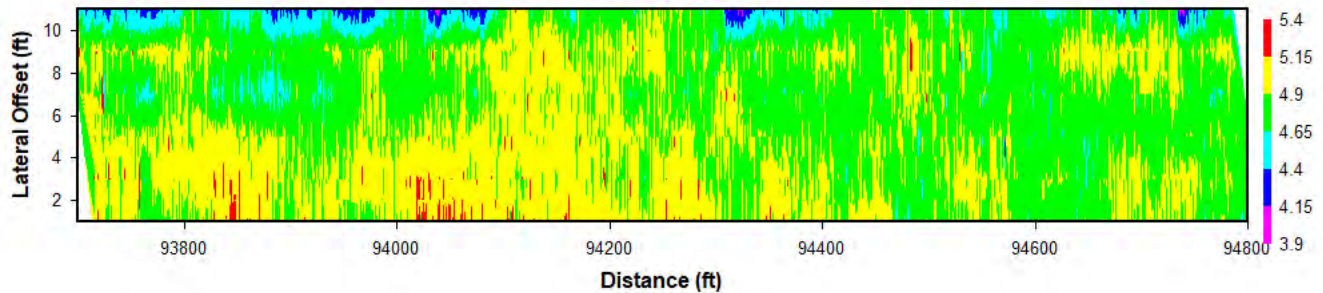
Rt1SB_Station 937 - 948
Passing Lane

Data collected and exported to excel to determine the range and average dielectric values of each sensor along Route 1, South Bound, Travel Lane. Station 937+00 - 948+00.

Lower dielectrics near the shoulder joint are displayed in blue.
