# Road Evaluation

## Kentucky Transportation Center Conducts Interstate Condition Assessment

**The Kentucky Department of Transportation requested pavement assessment of a questionable section of Interstate 65. The information from the five mile area to be inspected would be used to assist designers in the event this section of roadway had to be reconstructed or rehabilitated.**

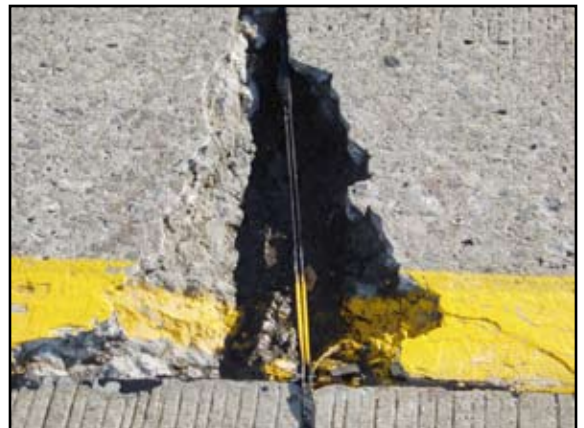
Two 900 MHz antennas were used to collect data at three scans per foot. With this method, the data collected was used to show degrees of moisture saturation within the pavement. GPR was also used to determine concrete thickness on three of the six highway lanes. The depth of the sub-grade material and its material composition was also measured with the system.

Several sections of the concrete paving surface on I-65 were identified to be areas of concern. GPR showed many areas to have less than four inches of dense grade aggregate (D.G.A.) beneath the concrete surface, which is a concern because they could become saturated in the future and require extensive repair. Differential settlement was also shown to occur between different driving lanes. Therefore, it was expected that the existing tie assemblies between lanes would not provide adequate support to deter further settlement.

Positive conclusions were also drawn from the GPR assessment. The transverse dowel bars were found to be in good condition, and most areas appeared to have adequate depths of D.G.A. material. The load-transfers over the transverse joints were also found to be in an acceptable range for the tested section. Lastly, the concrete thickness for the project was an average of 10.5 inches or greater.
